PROPERTY INSPECTION REPORT

Dynamic Property Inspection
1701 Cimarron Tr.
Grapevine, Tx 76051
817-442-9100

Inspected By: Stephen Ferguson 7807
Inspection Date: 6/23/2005

1701 Cimarron Tr.
Grapevine, TX 76092

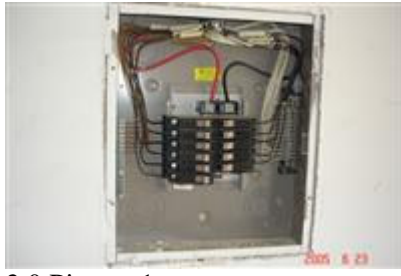
2.0 Picture 1

1. Remove panel board cover and inspected electrical panel. No defects were found.

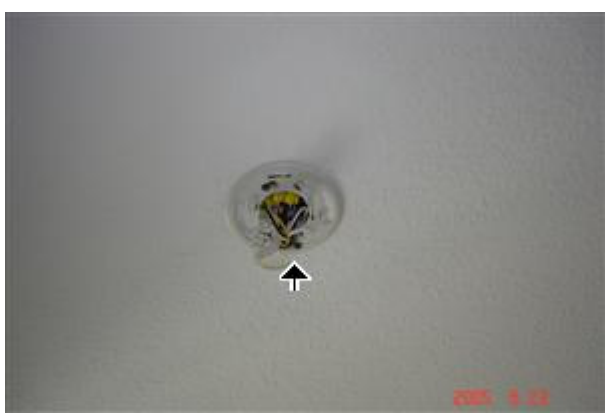
2.1 Picture 1

1. Smoke detector missing at upstairs hallway.(See picture 1).

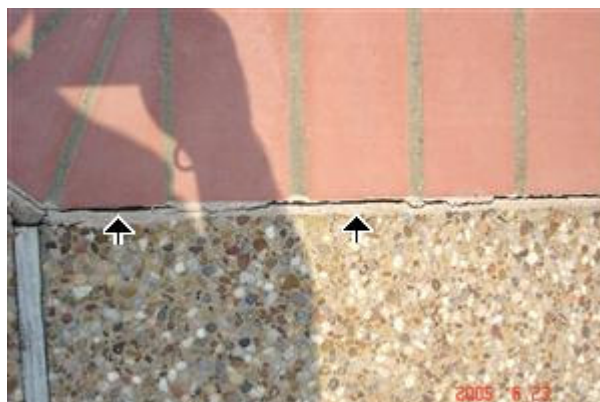
1. Small leak at pool filter.
2. Deco seal between red tile coping and deck is cracked and worn.(See picture 1).
3. No vortex drains at bottom of pool. This is a required safety item.
4. Flapper doors missing at both skimmers.
5. Grout cracked at several locations between blue pool tile and coping. (See picture 2).
6. Fence gates leading into pool area opens inward toward pool. This is required to open outward and latch needs to be 54 inches high.
7. Back door in home does not sound alarm when opened. This is also a required safety item for small children.
