COMMERCIAL BUILDING INSPECTION REPORT

Prepared For:
Mr. Dan Glassanos

Property Address:
4139 Centurion Way
Addison TX 75001

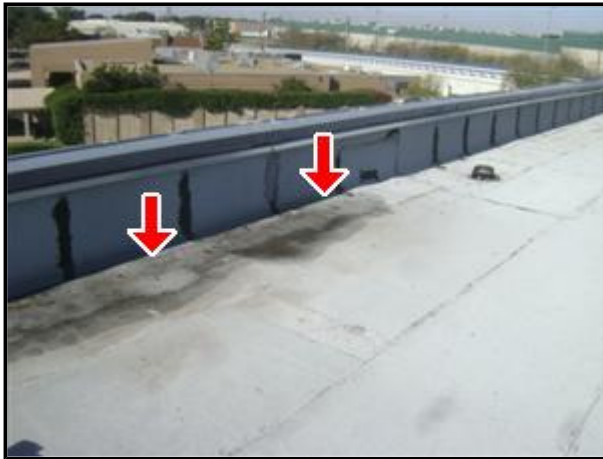
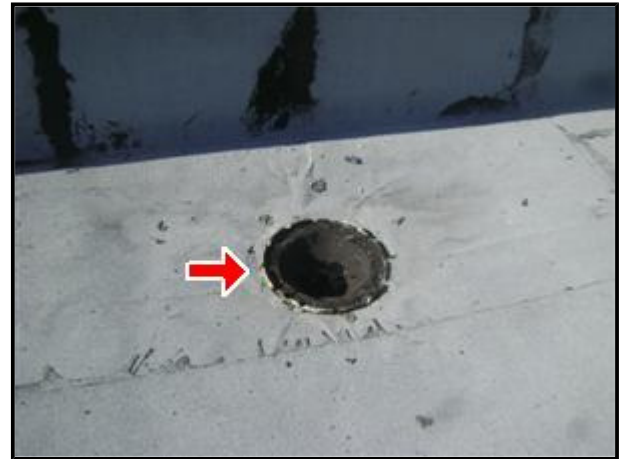
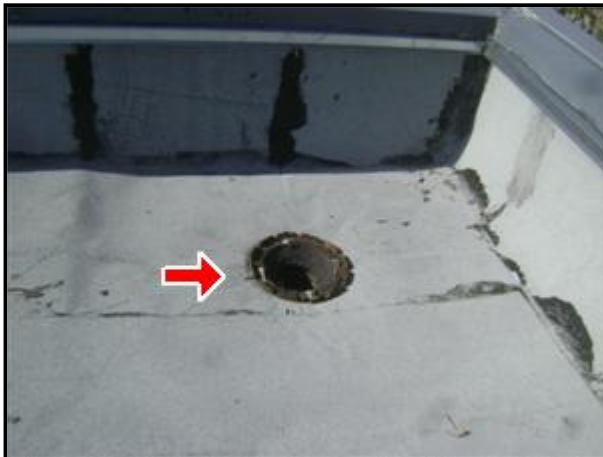
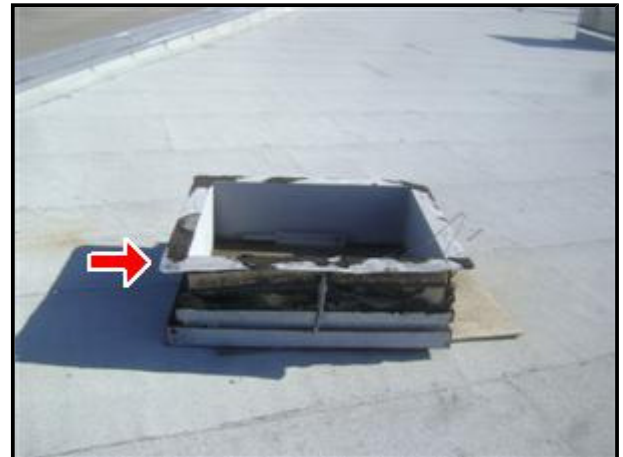
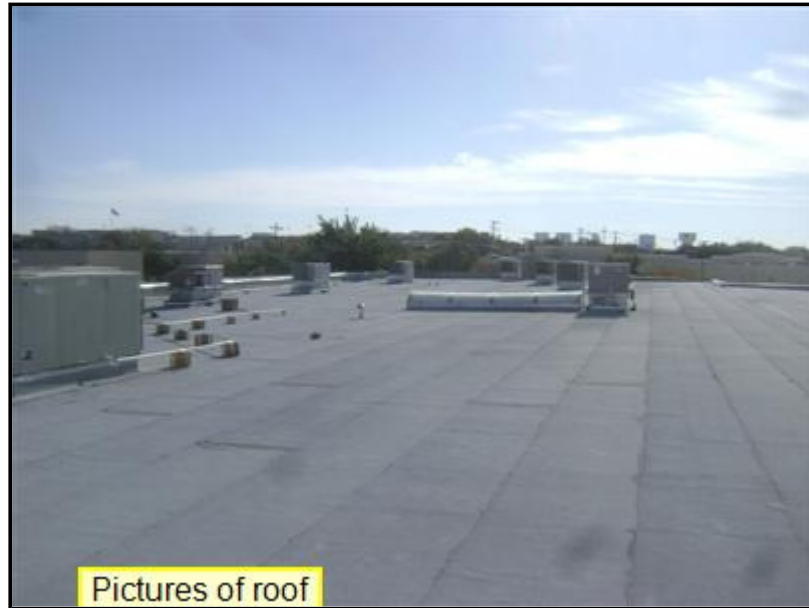
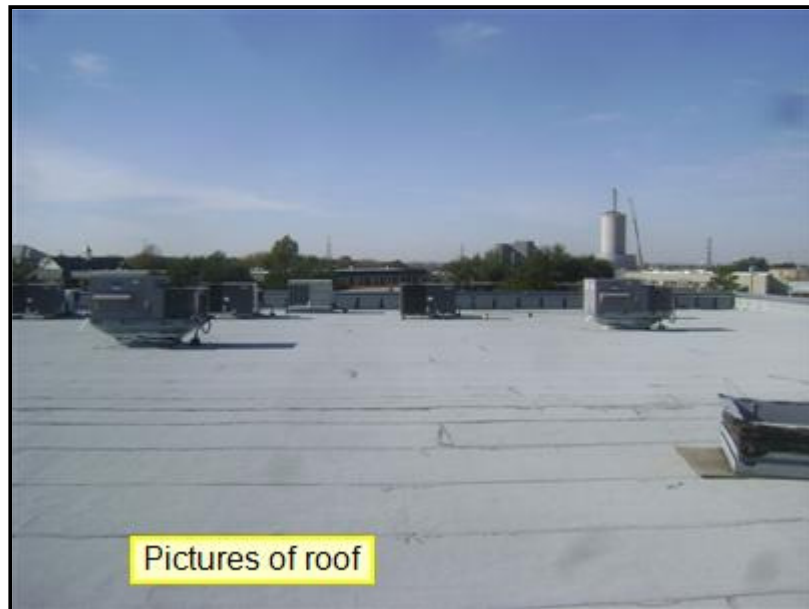
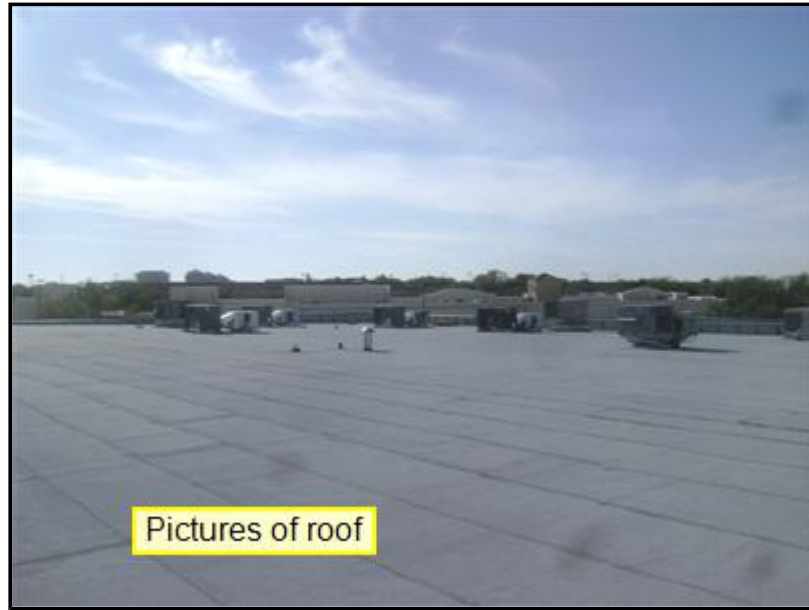
1. Walked entire roof. Roof is new and in good condition. There were two of the drain covers missing. These will need to be installed to keep debris from entering the drain. The roof drainage appeared normal. There was some standing water on the west side.(Picture 1,2,3)
2. Old components and tar buckets left of top of roof. These items need removed so they don't blow off onto someone's car. (Picture 4)
3. Awning over loading dock has some rusted attach brackets.(Picture 8)

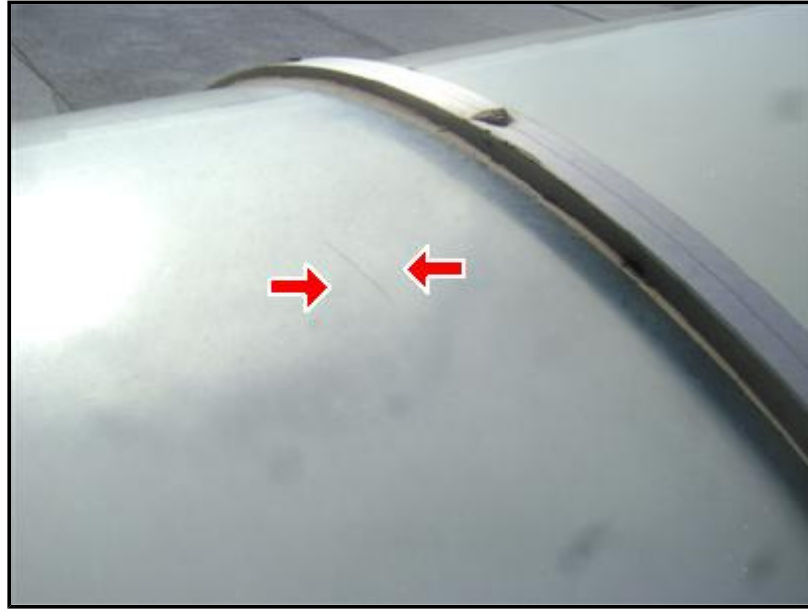
1.2 Picture 1

1. There were several small cracks in the skylight. They did not appear to be large enough to leak.(Picture 1)

1. Skylight has small cracks in several places. See pictures under roof section.

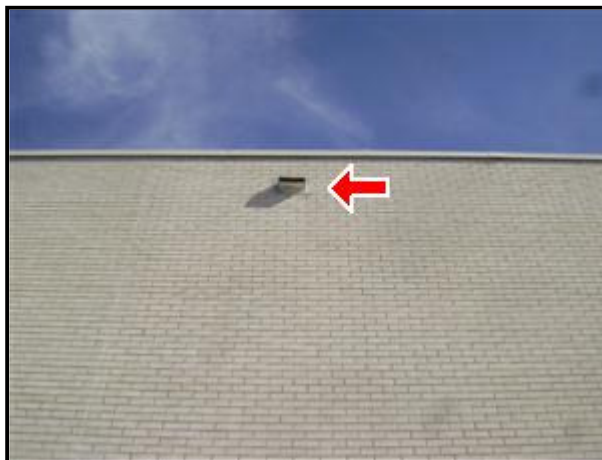
1.5 Picture 1

1. There are no downspouts on west side building coming down the wall. They do have them in the front. The windows on this side appear to have water leak into them in the past. See comments under windows section. This may be why water is leaking into them. These drains are located directly above the windows on west side of building.

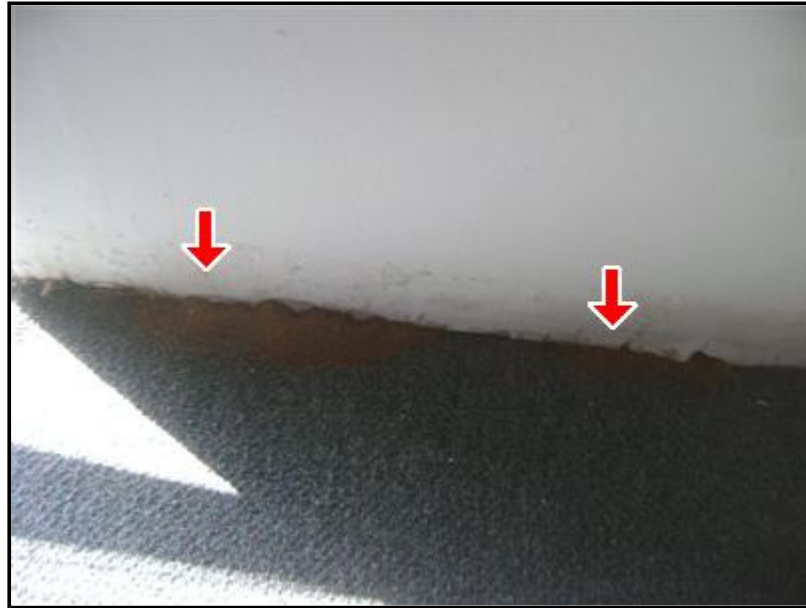
2.1 Picture 1

1. Ant beds inside building on west side. (Picture 1)

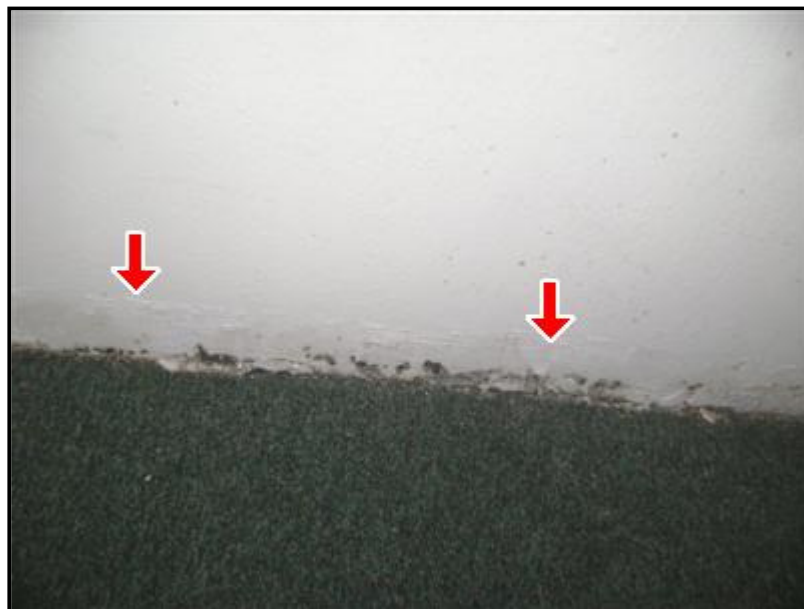
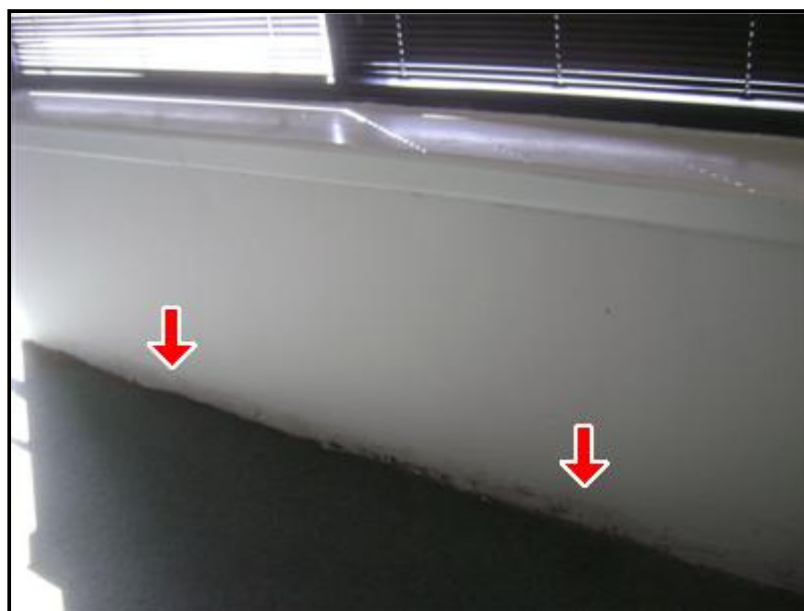
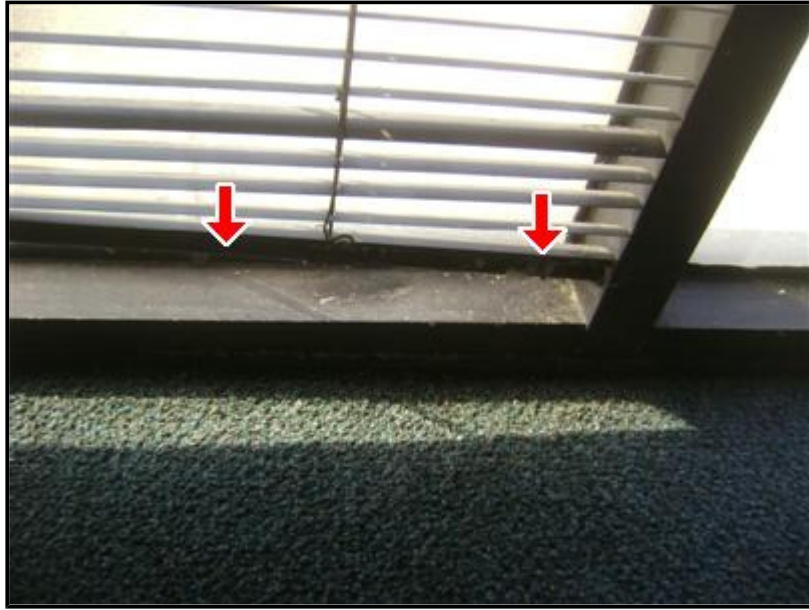
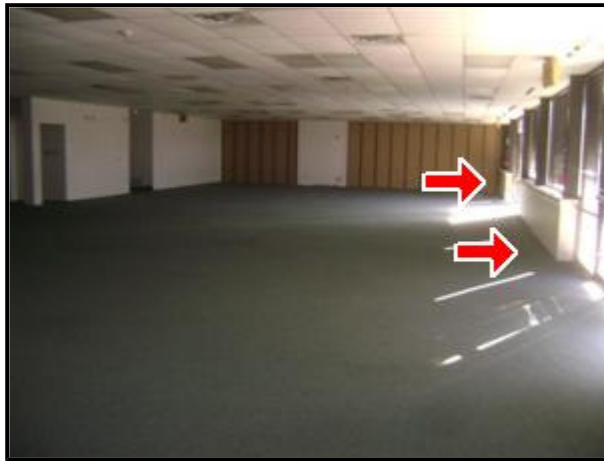
1. Windows leak into wall area on west side of building in several areas. They have been caulked which is a temporary repair. This may be leaking due to the roof drainage system draining directly above these windows. There are water stains on the wall below these windows and the wood cabinet has water damage also.(Picture 1-4)
2. Tinting on windows coming loose on many of the windows and some of the frames are corroded. (Picture 5)

1. Windows leak into wall area on west side of building in several areas. They have been caulked which is a temporary repair. This may be leaking due to the roof drainage system draining directly above these windows. There are water stains on the wall below these windows and the wood cabinet has water damage also.(Picture 1-4)
2. Tinting on windows coming loose on many of the windows and some of the frames are corroded.(Picture 5)

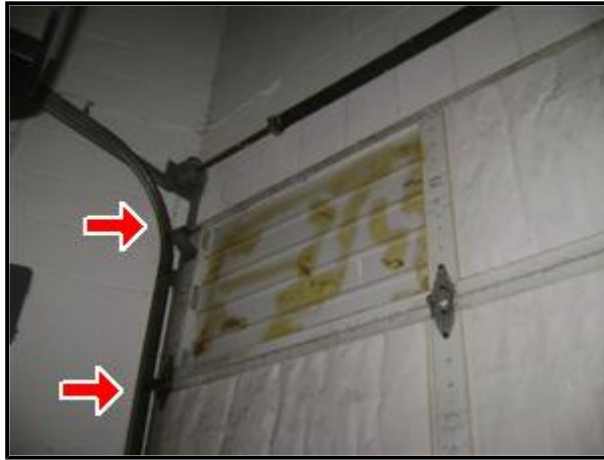
2.3 Picture 1

1. Motorized roll up door needs assistance to go up. Tracks need adjusted.
2. One roll up door has a broken lift cable and does not open.(Picture 1)

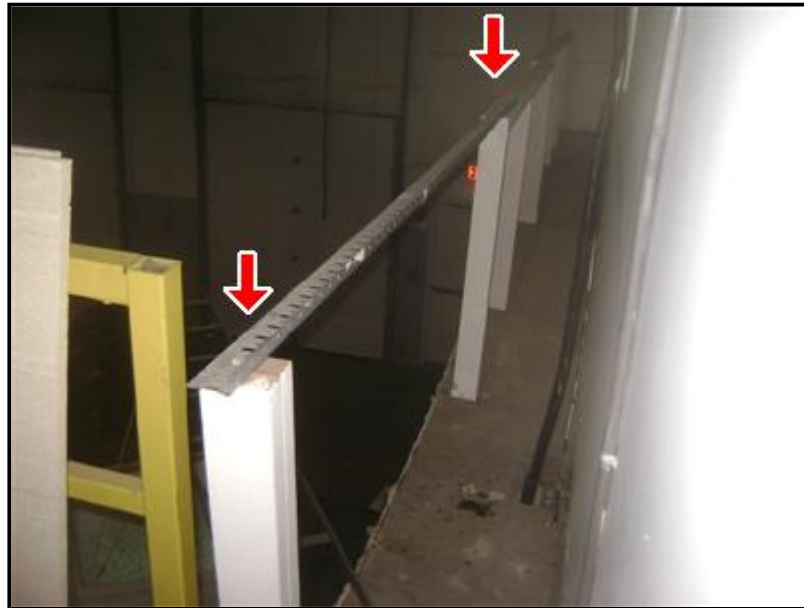
2.4 Picture 1

1. Upstairs storage area in warehouse do not have proper handrails installed and are loose.(Picture 1)
2. Bumper stop damaged on loading dock.(Picture 2)
3. Bumper pole damaged at loading dock.(Picture 3)

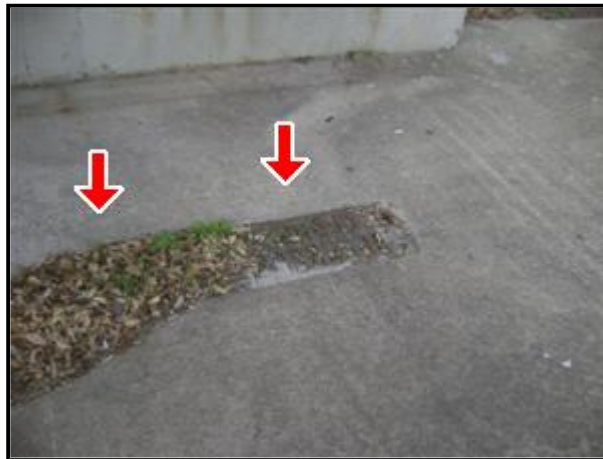
2.5 Picture 1

1. Landscaping is in poor condition. This is due to sprinkler system not working.
2. Drains filled with leaves at loading dock.(Picture 1)

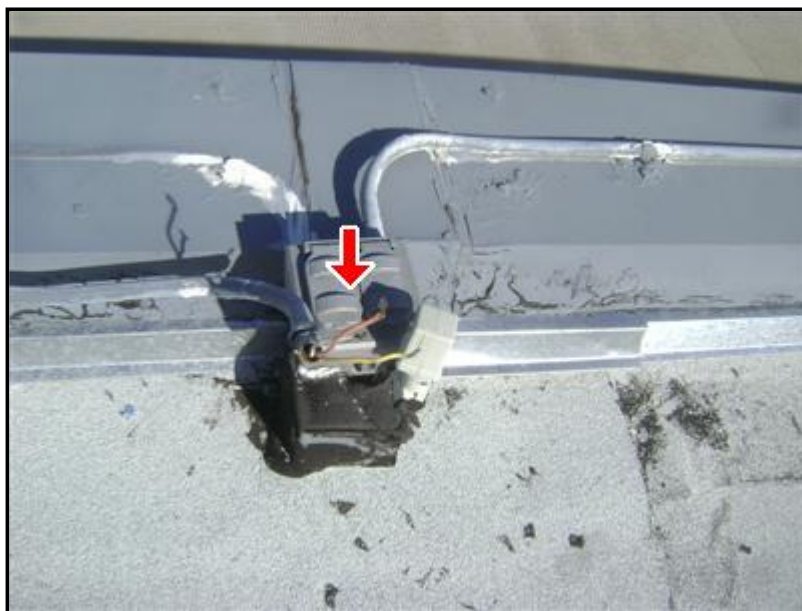
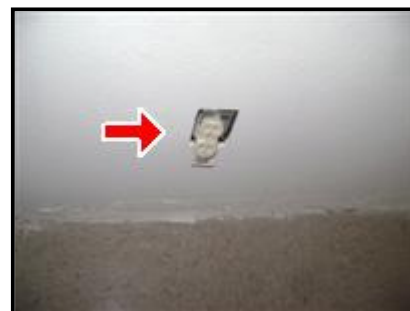
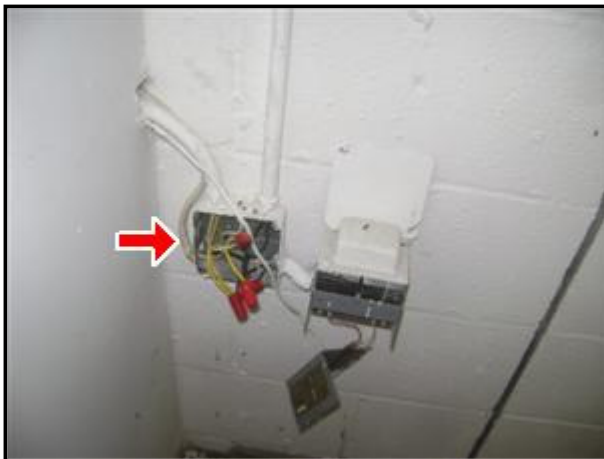
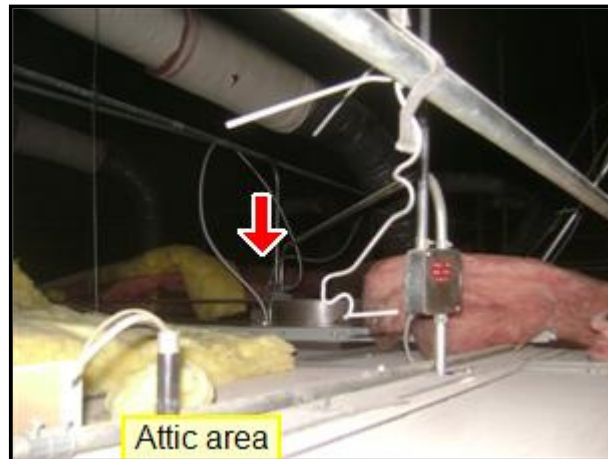
1. Outside building lights do not work. The wires are not connected at top where previous roof replacement was done. The light conduit also needs secured on top of wall going around roof. It is missing some of the mounting straps. (Picture 1)
2. Outlet loose on wall in back NW room. Needs secured.
3. There are several J-boxes in attic area and upstairs storage missing the covers. All J-box's are supposed to have covers installed. (Picture 3)
4. Light lens missing at light fixture in hallway. (Picture 5)

1. Outside building lights do not work. The wires are not connected at top where previous roof replacement was done.The light conduit also needs secured on top of wall going around roof. It is missing some of the mounting straps. (Picture 1)
2. Outlet loose on wall in back NW room. Needs secured.
3. There are several J-boxes in attic area and upstairs storage missing the covers. All J-box's are supposed to have

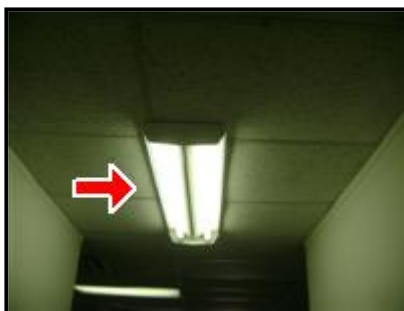
7.3 Picture 5

4. Light lens missing at light fixture in hallway.(Picture 5)

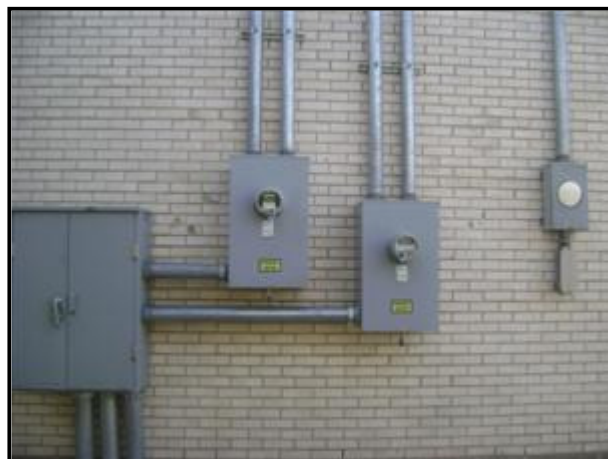
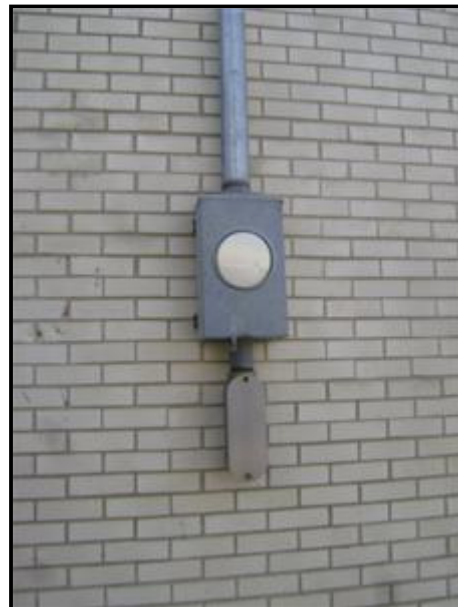
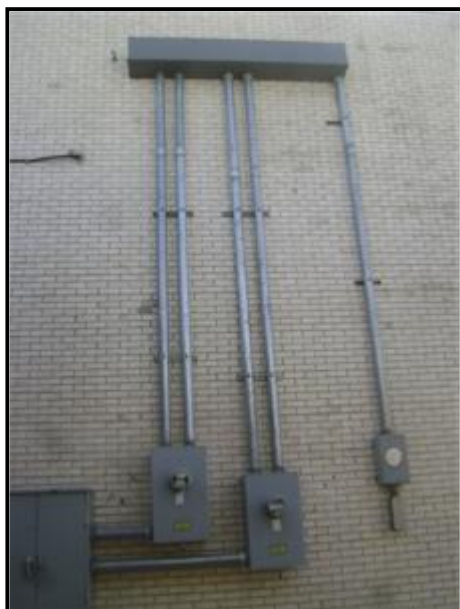
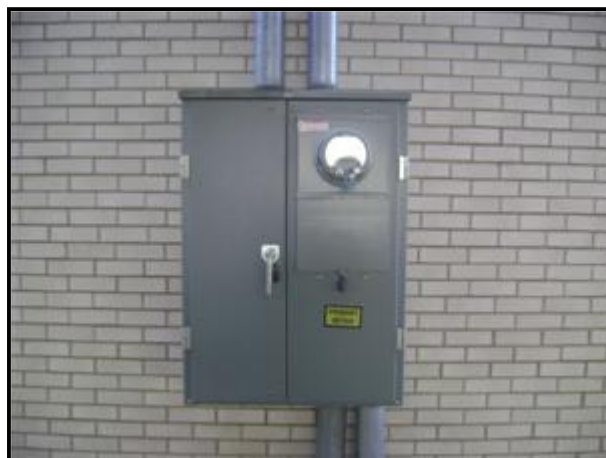
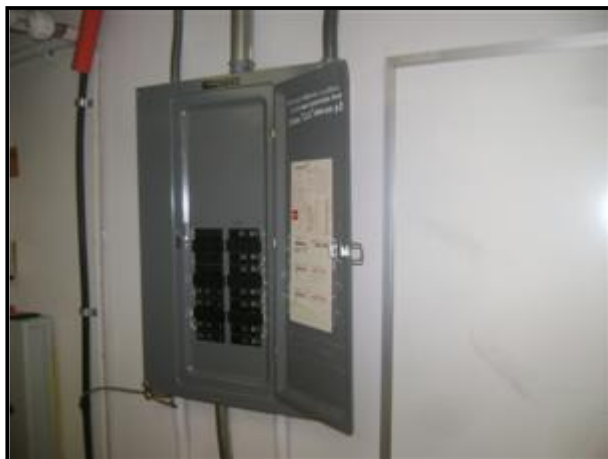
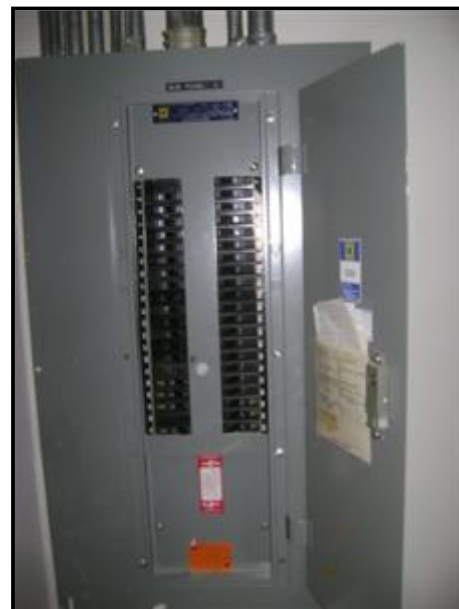
1. There are three sets of distribution panels inside building. There are three primary meters installed on east side of building. There are 2-225 amp service panels, 4-200 amp service panels, 1-600 amp service panel, 2-400 amp service panel, 1-800 amp safety switch, 1-600 amp safety switch, 1-400 amp safety switch. The panels are a mixture of Square-D and Sylvania manufacture type. They all appeared in good condition. (Picture 1-10)
2. The gutter box on north panel area in warehouse is missing a cover plate.(Picture 11)
3. Service panel covers are not taken due to business being conducted at time of inspection in the units and accidentally tripping breakers causing loss of business.

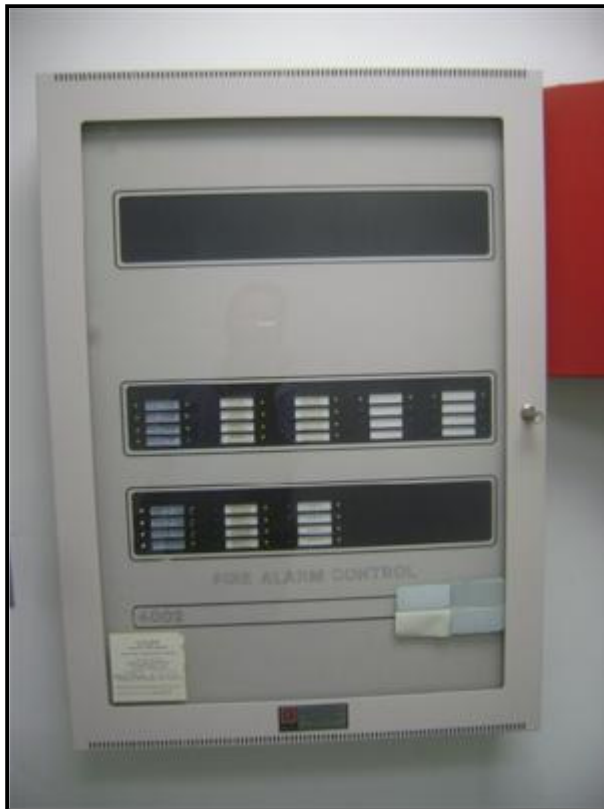
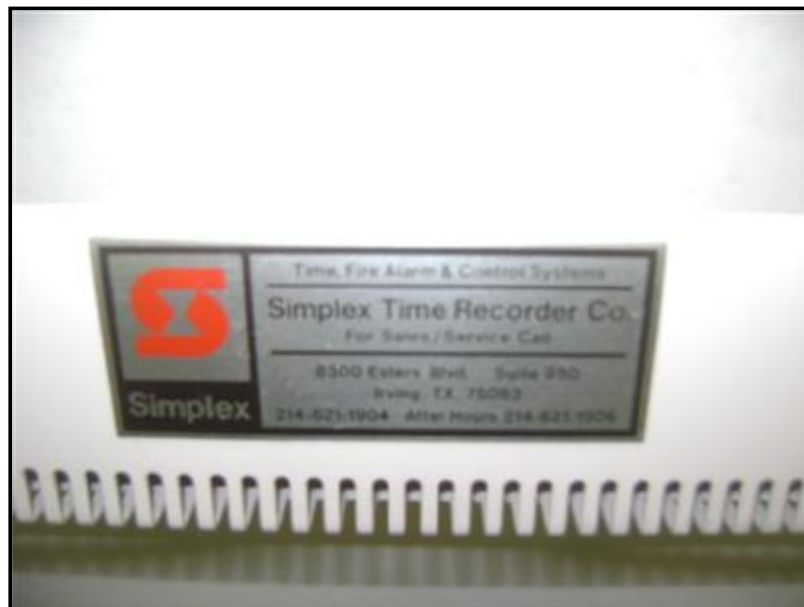
1. There is a fire alarm system installed inside building. We do not test these systems. There was no inspection date on the box itself which is located in the front office area.(Picture 1,2)
2. There are no building sprinkler system installed in this building. Some cities in the DFW metroplex require a sprinkler system as of 2008 if any remodeling is done to the building. Make sure you check with the city to see if this is going to be required to this building.

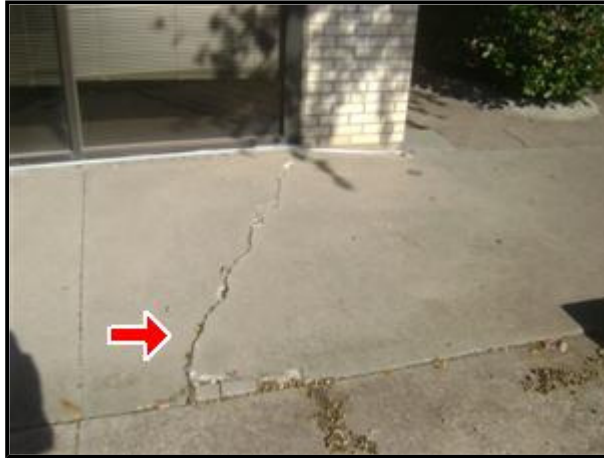
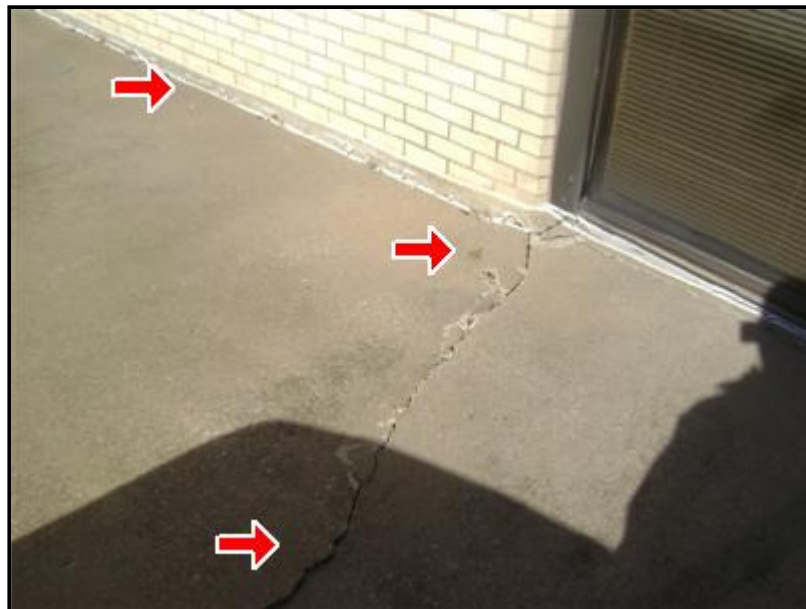
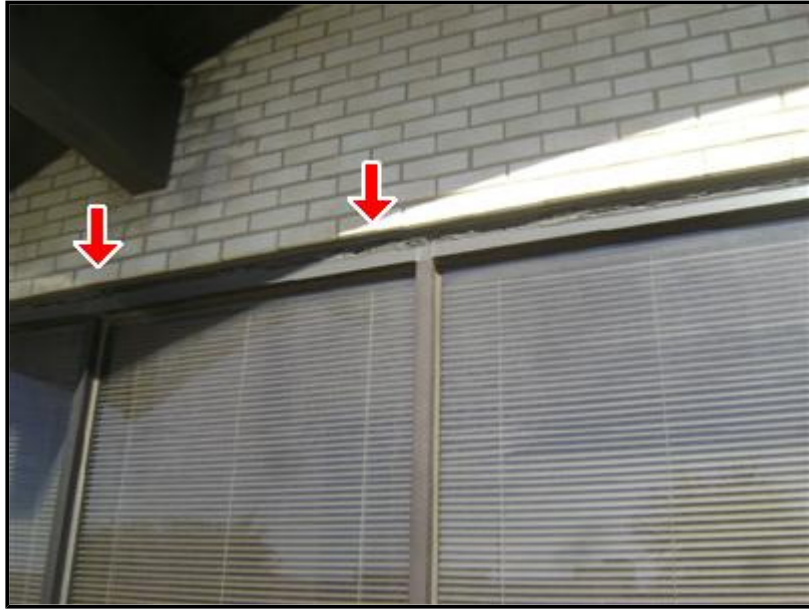
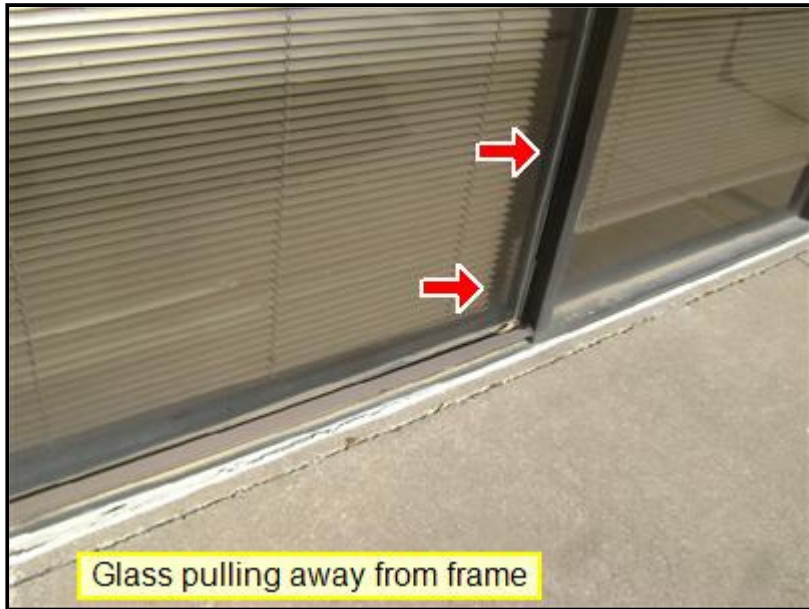
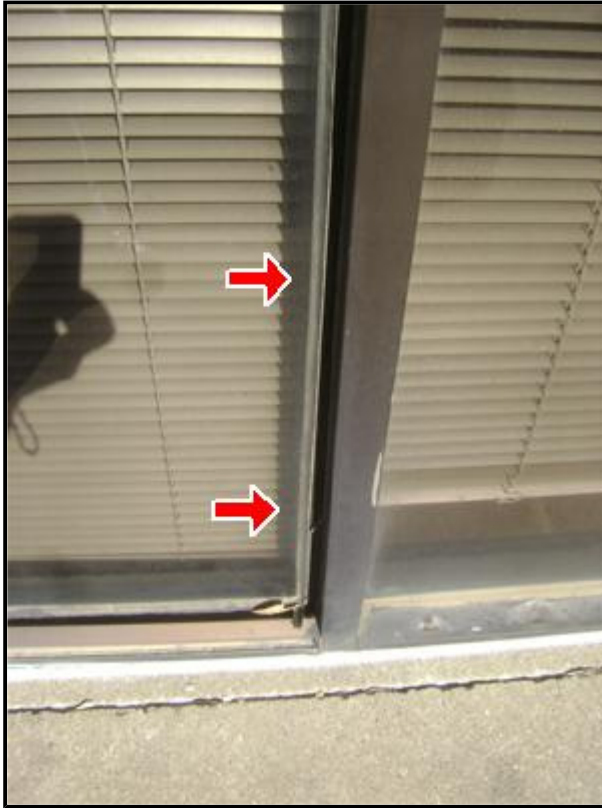
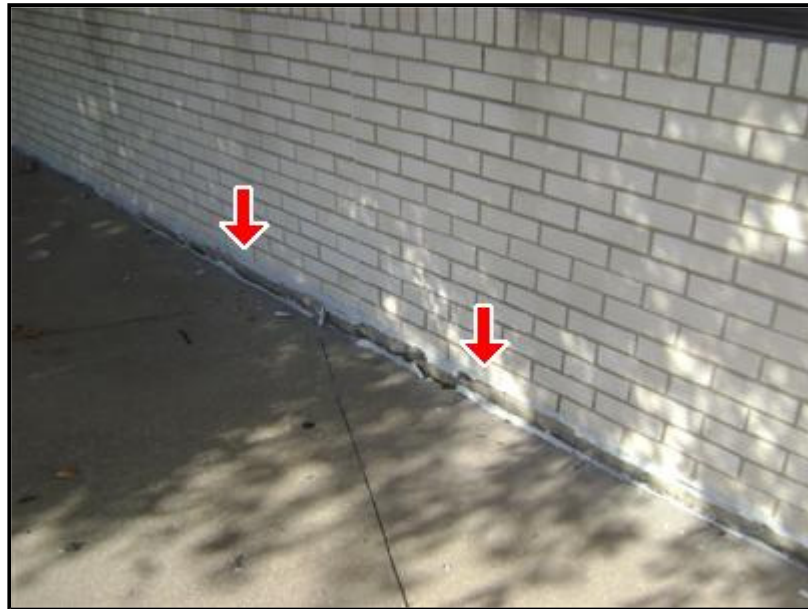
1. Sidewalk in front entry area is cracked in several places. This has caused the window and door frame to bend and the glass to separate from the frame. The sidewalk on the west side of building has dropped 4-5 inches. The engineer reported to me that this is not part of the main building foundation. The sidewalk area that has dropped was added. See structural engineers report for repairs and evaluation. This will be sent in a separate email. (Picture 1-6)

1. Sidewalk in front entry area is cracked in several places. This has caused the window and door frame to bend and the glass to separate from the frame.The sidewalk on the west side of building has dropped 4-5 inches. The engineer reported to me that this is not part of the main building foundation. The sidewalk area that has dropped was added. See structural engineers report for repairs and evaluation. This will be sent in a separate email. (Picture 1-6)

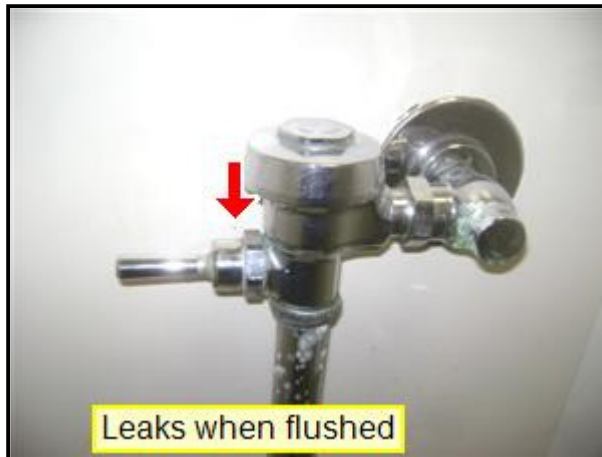
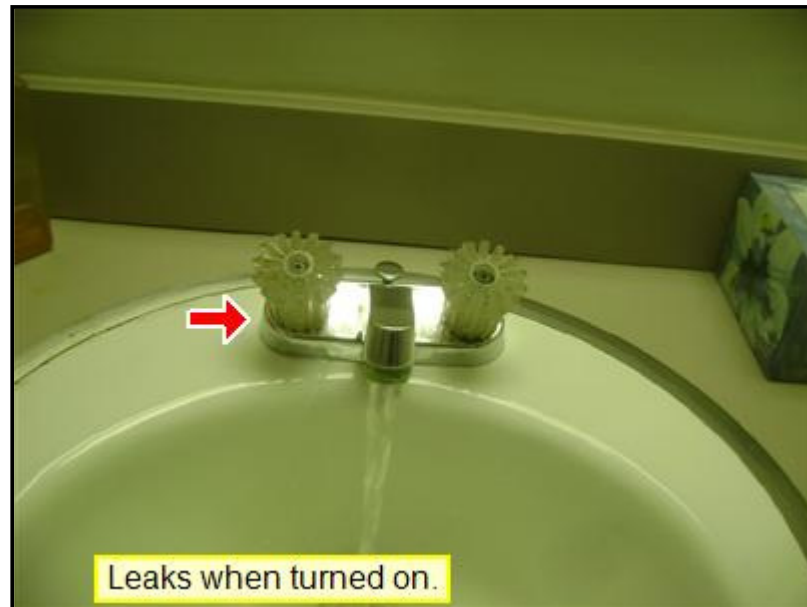
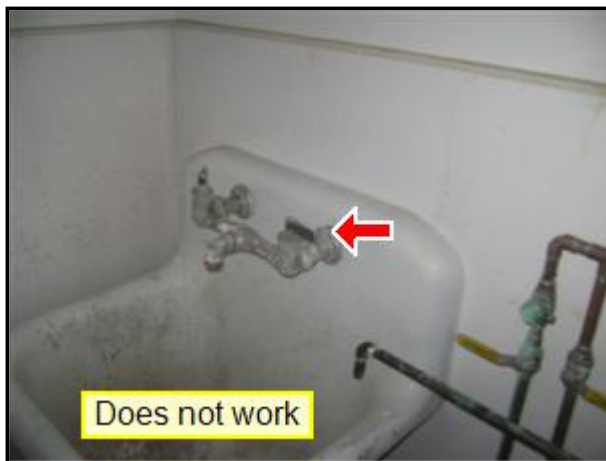
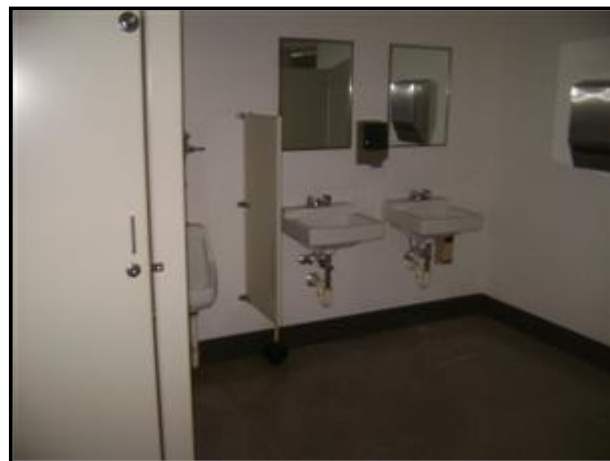
1. The plumbing fixtures throughout the building in the bathrooms is old and many of the faucets leak when tested. I would plan on updating the plumbing fixtures soon. This is normal when plumbing fixtures are not used and the seal and "O" rings dry up causing them to leak. (Picture 1,2,3,4) .

1. The plumbing fixtures throughout the building in the bathrooms is old and many of the faucets leak when tested. I would plan on updating the plumbing fixtures soon.This is normal when plumbing fixtures are not used and the seal and "O" rings dry up causing them to leak.(Picture 1,2,3,4) .

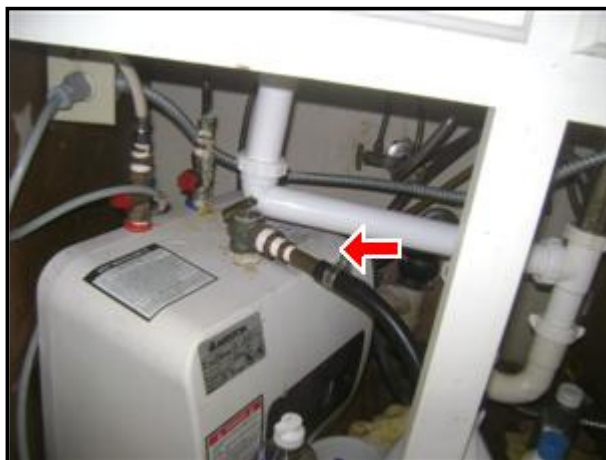
9.2 Picture 1

1. I located three water heaters. One gas and two electric. The only one that was working was the one under the kitchen sink. The other two did not work. There is no hot water at any sink except in the kitchen. (Picture 2,3)
2. The water heater under the kitchen sink does not have the proper material used for the T and P valve in it terminates under the cabinet. It is supposed to terminate in a drain or the outside of the building. (Picture 1)

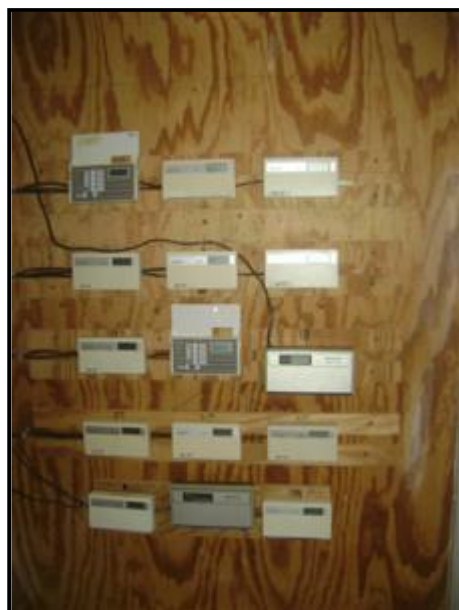
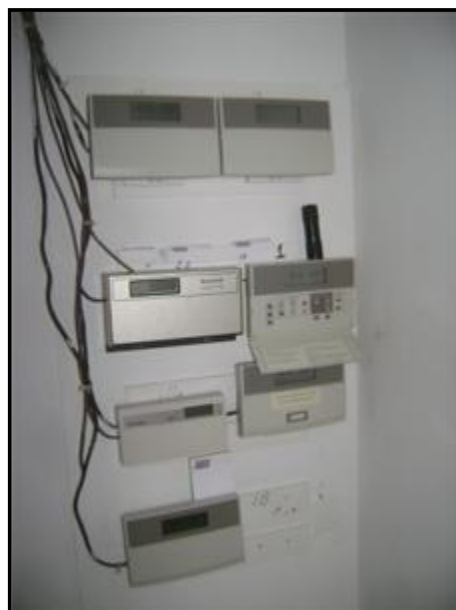
3. I tried to test all the heaters. The front and east office area worked normal. In the one closet that has seven thermostats installed only four out of the seven worked. The other three has no power and were blank. The closet that holds 15 of the thermostats none of them worked. Some had power but were blinking and you could not set the them. The heating and air conditioning system came on at several of the rooms on the west side with all the thermostat panels either blank or blinking. This is not normal and a HVAC company needs to come out and evaluate the systems to see why and what controls these areas.(Picture 1,2)

3. I tried to test all the heaters. The front and east office area worked normal. In the one closet that has seven thermostats installed only four out of the seven worked. The other three has no power and were blank. The closet that holds 15 of the thermostats none of them worked. Some had power but were blinking and you could not set the them. The heating and air conditioning system came on at several of the rooms on the west side with all the

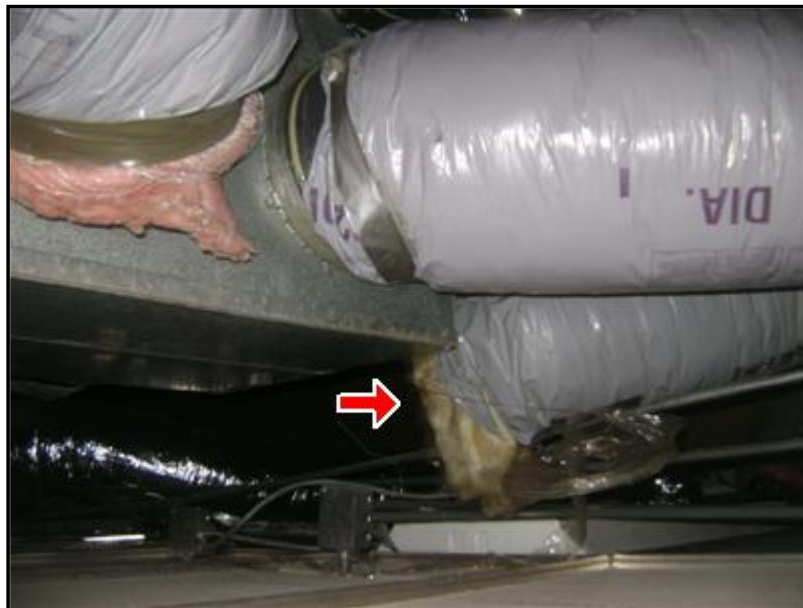
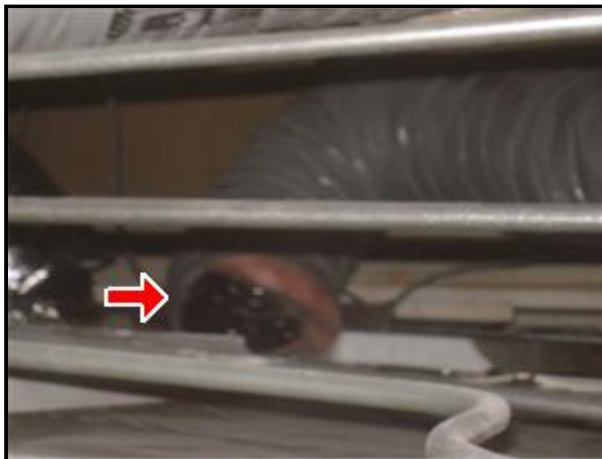
1. The ducts are not connected to furnace plenum at front section of west vacate room area .(Picture 1,2)

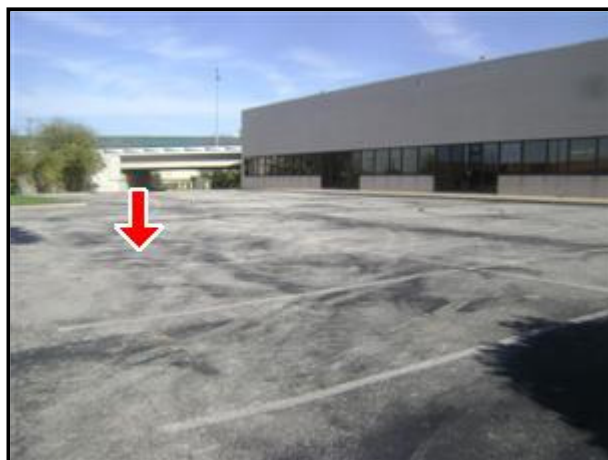
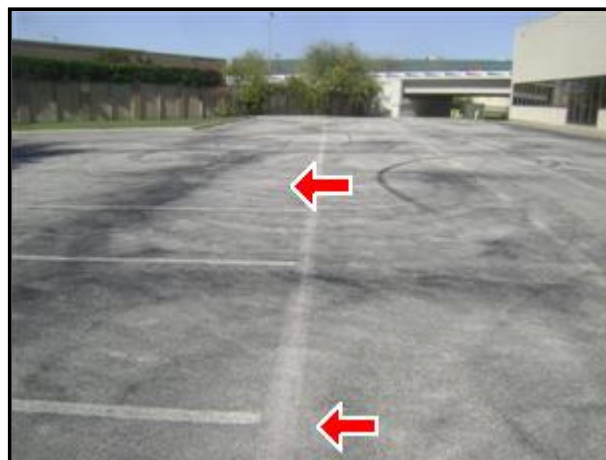
1. Striping and fire lanes worn throughout parking lot. (Picture 1,2)

1. Stripping and fire lanes worn throughout parking lot. (Picture 1,2)

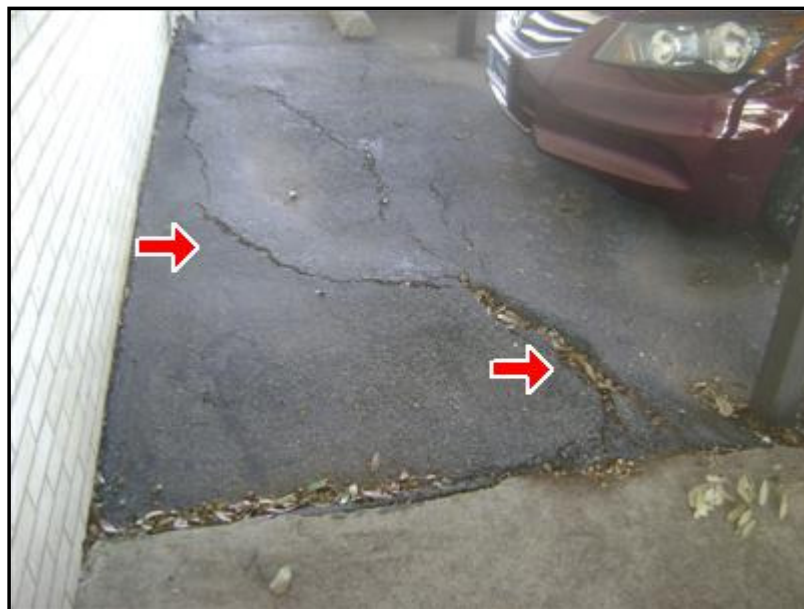
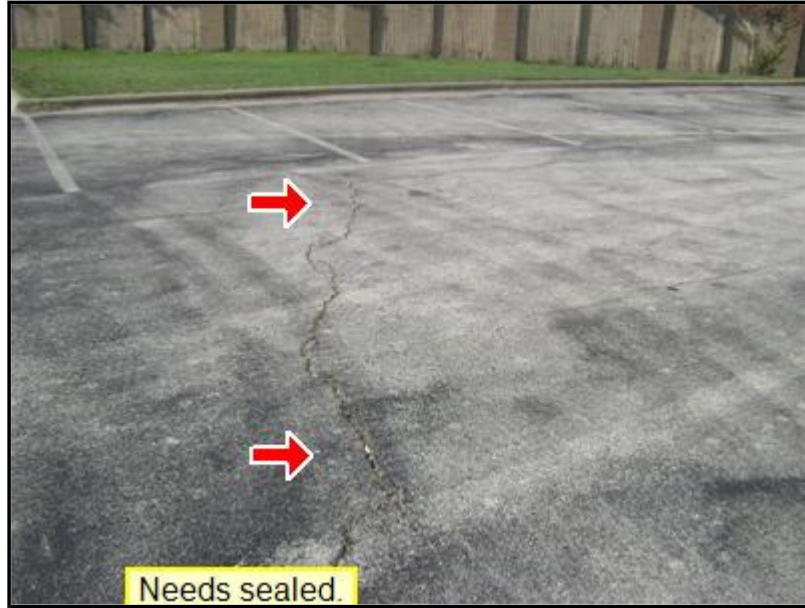
1. Parking lot is in god shape. There are some cracks in the asphalt that need to be sealed to keep from getting worse. There is also some asphalt buckled by covered parking area in front.(Picture 1,2)

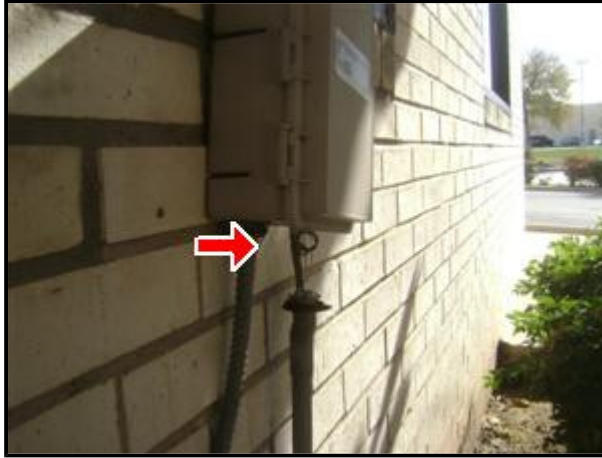
13.1 Picture 1

1. Sprinkler control box loose on wall and has conduit pulling away from box. Control box is located on west side of building.(Picture 1)
