COMMERCIAL BUILDING INSPECTION REPORT

Prepared For:
Mr. Dan Glassanos

Property Address:
4139 Centurion Way
Addison TX 75001

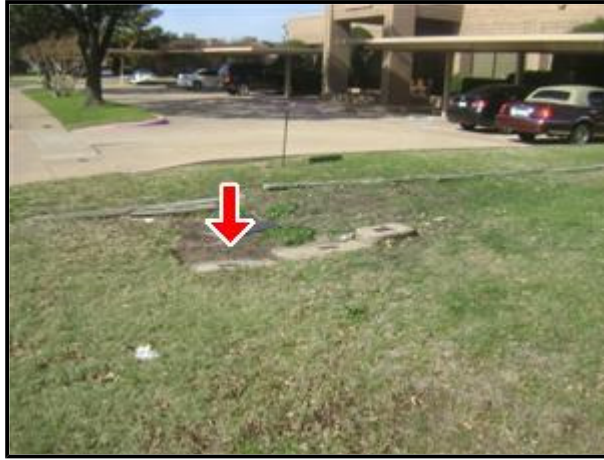
9.3 Picture 1

1. Water meter is located at the NW corner of property by street. (Picture 1)

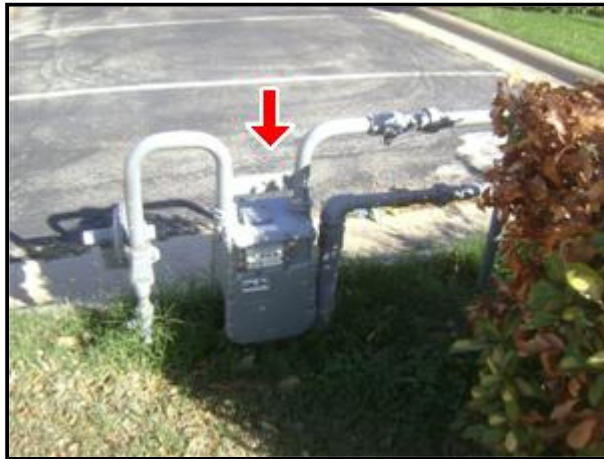
9.4 Picture 1

1. The one gas meter is located at the SE corner of property. The only components that were using gas were the two heaters in the warehouse and the water heater at the upstairs storage room in warehouse area.
